# **Report of the Project "Wadi Abu Dom Itinerary"**

## **Third Season, 28.2.-21.3.2009**

**Angelika Lohwasser**  
University of Muenster, Germany

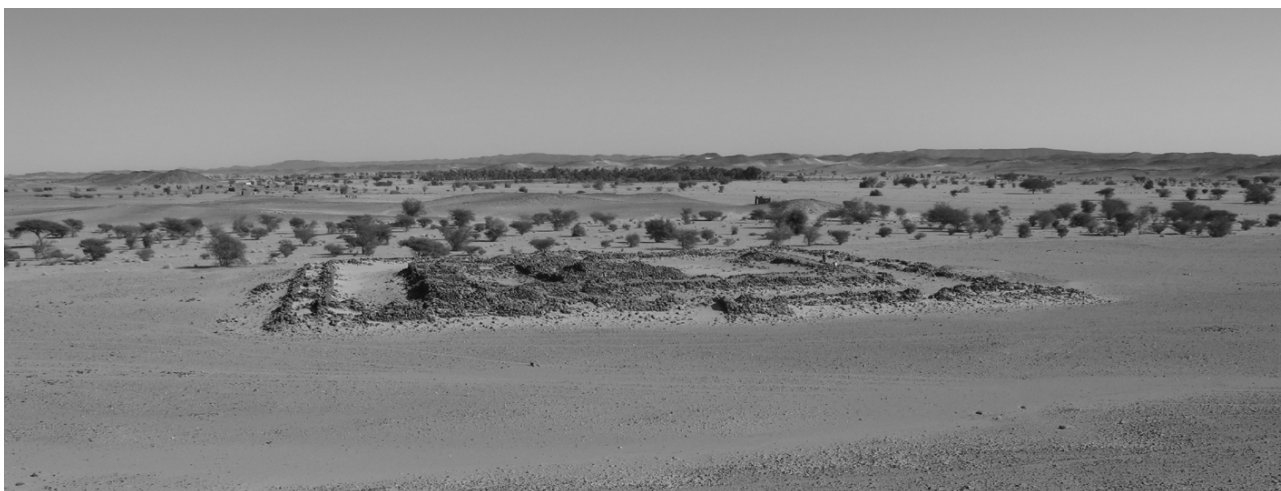
Fig. 1: Umm Ruweim from East

- a) architectural documentation of the ruin of Umm Ruweim, accompanied by small-scale sondages (fig. 1). Detailed measuring and architectural description of the whole building, drawing a plan, measuring with Totalstation (Dieter Eigner). Removal of sand as well as 4 sondages should help to clarify the building history (for the location of the areas of sand removal and the sondages, see fig. 2). Therefore we hired three workers of the people living nearby, who were trained and supervised by Mohammed Toun. The archaeological documentation was done by Tim Karberg with the help of Laura Haupt.

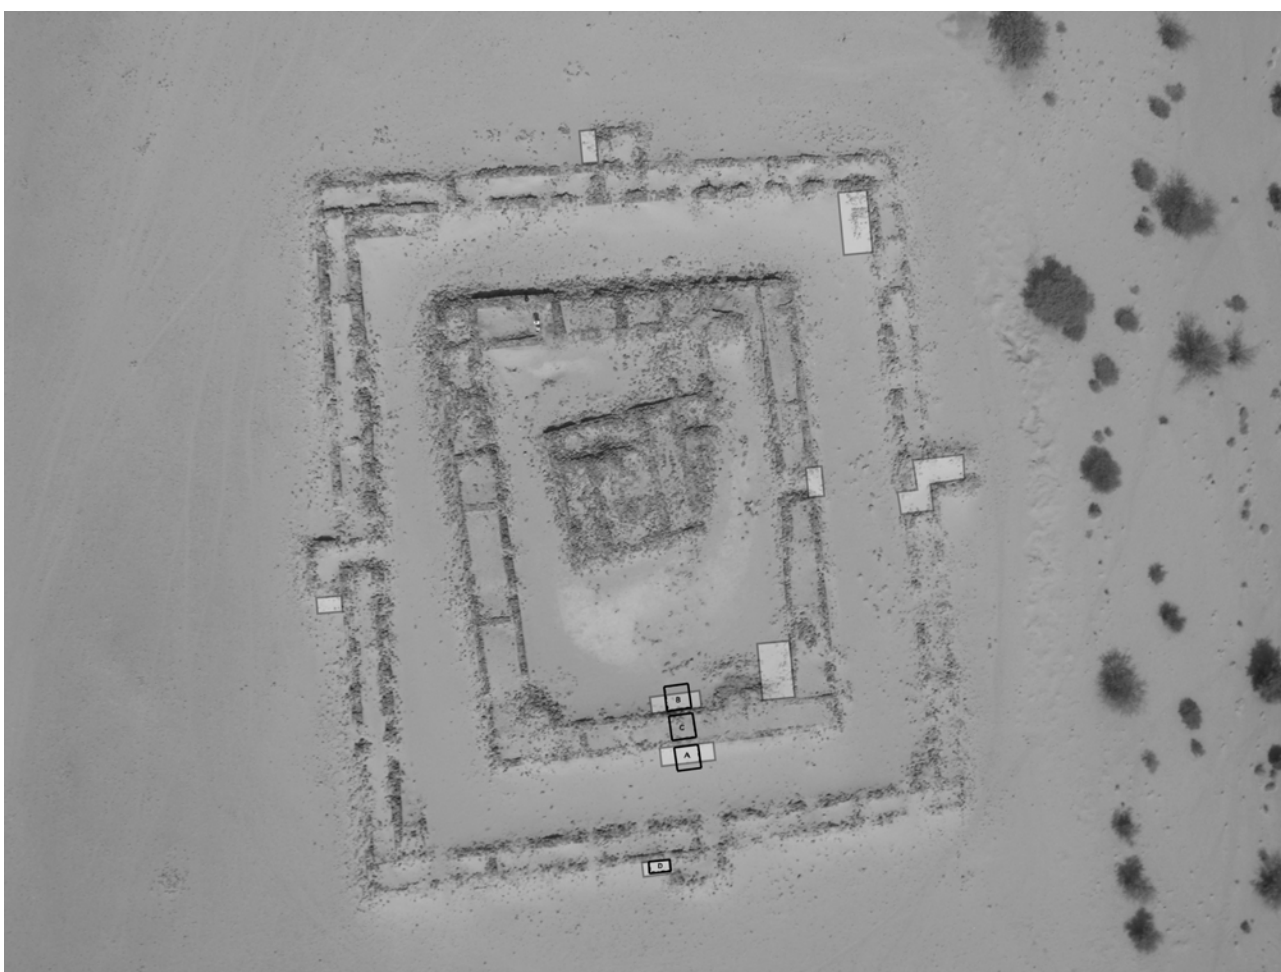
Fig. 2: Umm Ruweim I, light = places of removal of sand and debris, black squares: sondages A-D

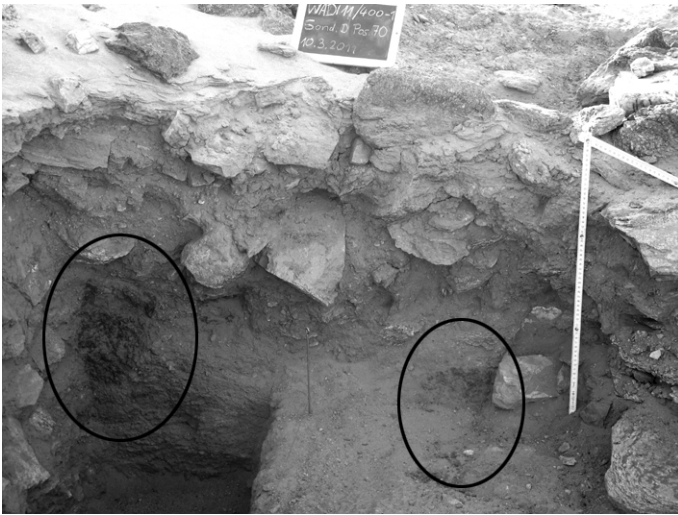
Fig. 4: Sondage D, wooden beams at blocked door

As already mentioned by Chittick, the ruin of Umm Ruweim consists of two squares with rooms and a central building. Additional to the plan and remarks from 1955, we can state that the building has four entrances in L-form (change of direction), the main entrance is in the East. The other three entrances were blocked in a later stage of usage. In sondage D at the southern entrance we identified traces of wooden beams, therefore one can suggest wooden doors to close the entrance (Fig. 4).

D: In this small sondage we only tried to reach the natural soil for measurements, this sondage was nearly without finds. At the entrance door, two rests of wooden beams, possibly from a wooden door, but possible also from another construction, came to light.

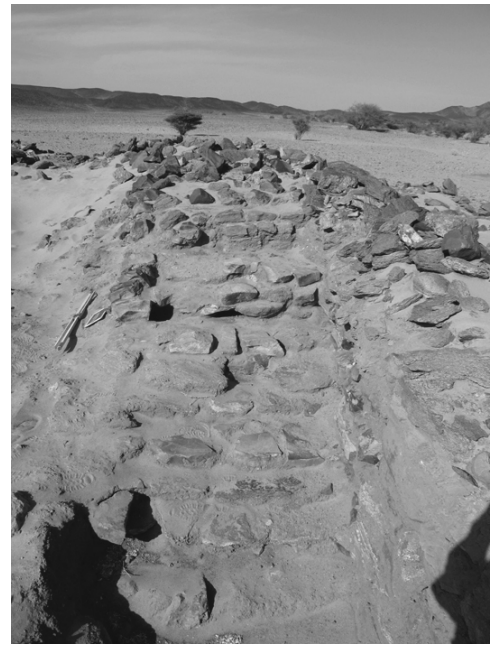
Fig. 5: Staircase 4

There are staircases in each corner of the outer enclosure (Fig. 5), but also staircases or ramps in three corners of the inner enclosure. In the central building there is one staircase/ramp of the same type. The clearing from sand at staircase 5 brought to light that at this "staircase" there are no stairs of stone, although the sloping sidewall hints to that, but a ramp.

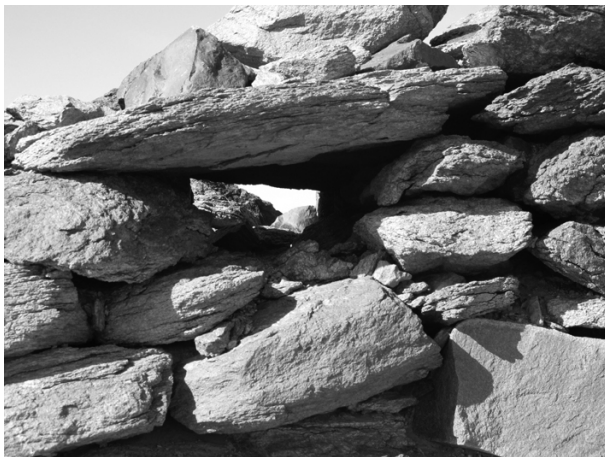
Fig. 6: Window

In every part of the building there are small openings, about 20 x 20 cm (fig. 6). They provide ventilation and some light. As these openings are quite irregular in their spacing and in some parts quite rare, we can exclude holes for beams of scaffolding. Moreover, these openings are no omissions of stones in the wall but intentionally built with small architraves.

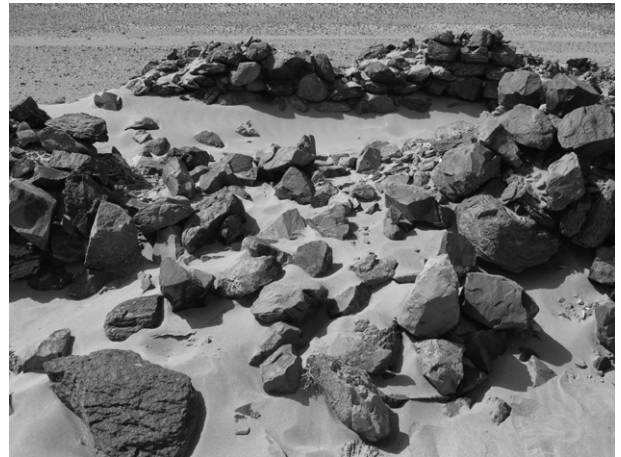
Fig. 7: Blocked door

In some parts of the building there are many doorways, most of them 140 cm wide, some 120 cm, others even 160 cm. But the main entrance is only 1 m wide, which led to the conclusion, that the inner doorways were not closed by wooden doors. Some of the doorways were blocked with dry stone masonry (Fig. 7). The blocking is visible in two types:

1. blocking similar to the masonry of the building's main walls with long slabs of gneiss, probably done already during the first phase of building. We suggest that these openings are only for the transport of material, since in some of these blockings again some small windows were installed.
2. later blocking, probably during the usage of the building, done by small blocks of quartzite.

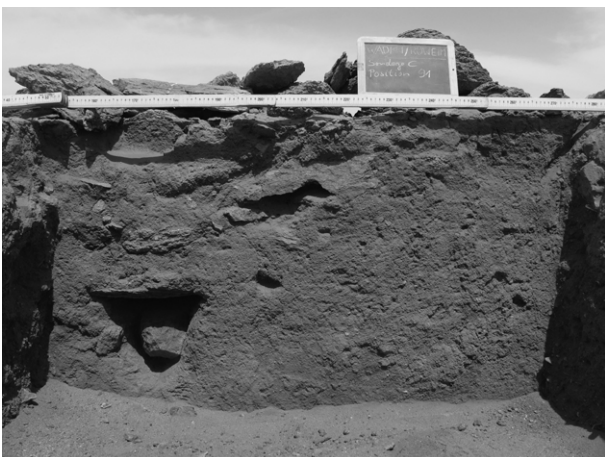
Fig. 8: Wall with mortar

We were also happy to find the evidence of plaster (Fig. 8). In the sondage C we realized that the inner wall of the inner enclosure was most probably plastered on both sides (although at this stage it

is still to be verified if it is really plaster), but the outer wall of the inner enclosure is without plaster. The intermediate walls seem to connect to the plaster with a join. The plaster at the inner wall is visible on the wall and in the profile, where it seems to be clear that it was done in two different chronological phases, since they started from different floor levels. It seems that we can speak of a building phase with the first layer of plaster and a restauration phase with the second layer of plaster.

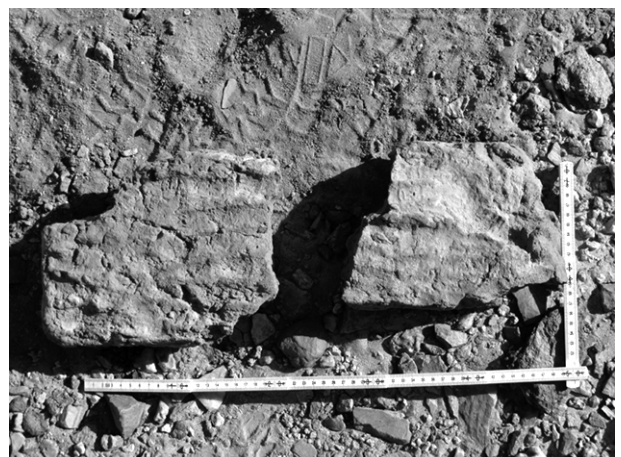
Fig. 9: Mudbricks

We also found some mudbricks (Fig. 9). In one robber's pit in the inner enclosure and in sondage A we identified unburnt bricks of Nile clay. It seems that the dry stone masonry was topped by brickwork. Moreover, the debris of the stones is all in all too little to reach sufficient height of the rooms. We have to deal probably with barrel vaults by mudbrick above the long rooms of the outer border of rooms.

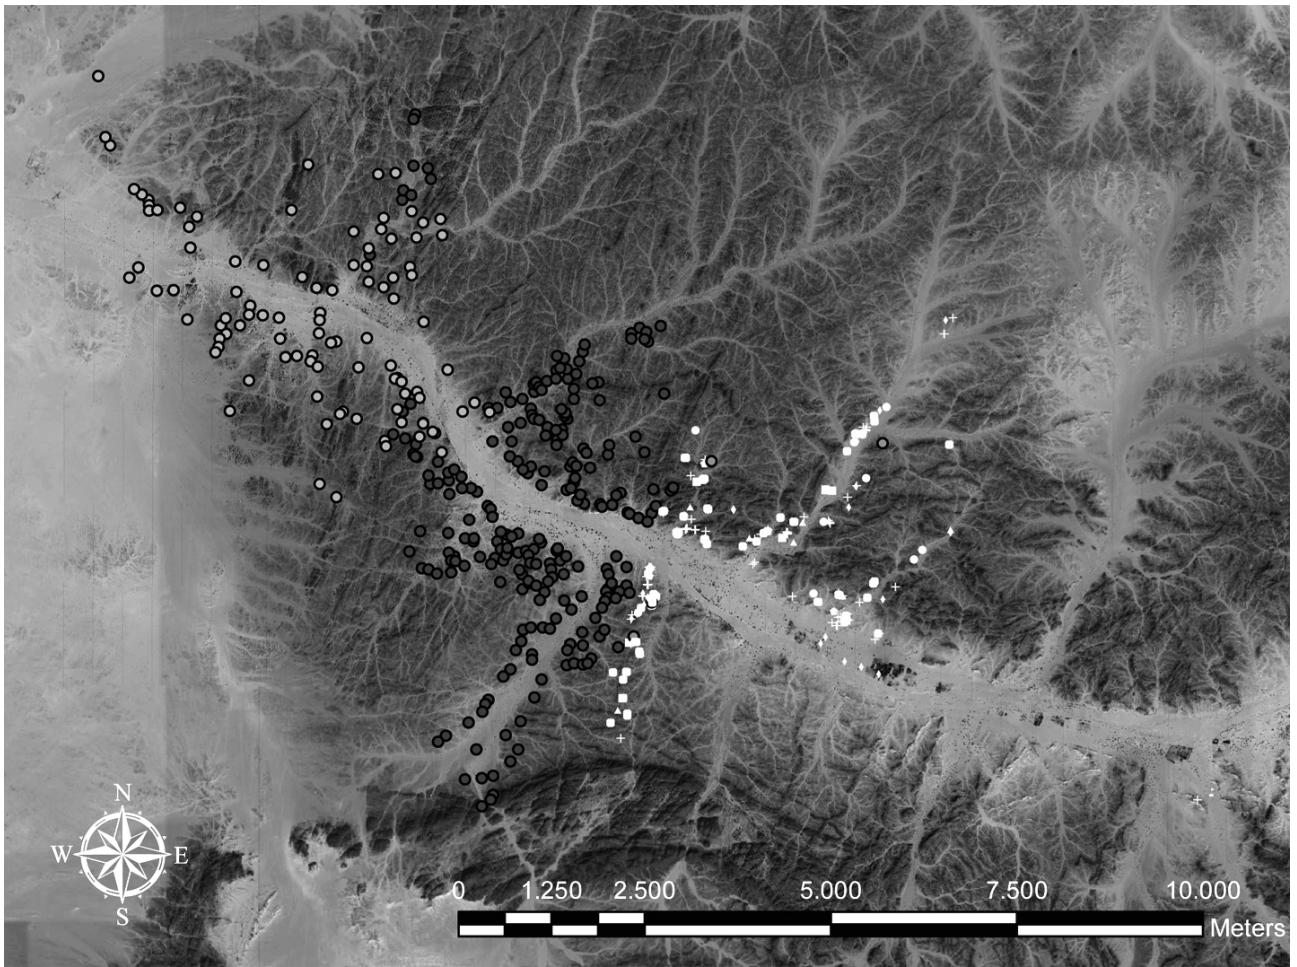
Fig. 10: Map of the surveyed area (2009-2011), white dots are sites identified in 2011

b) Survey (see Fig. 10, see attached site-list)

This year our survey covered the length of 3,7 km along the Wadi Abu Dom up to N 18°24'21,0" E 31° 59' 33,5". All in all, 3,7 km are covered up to now.

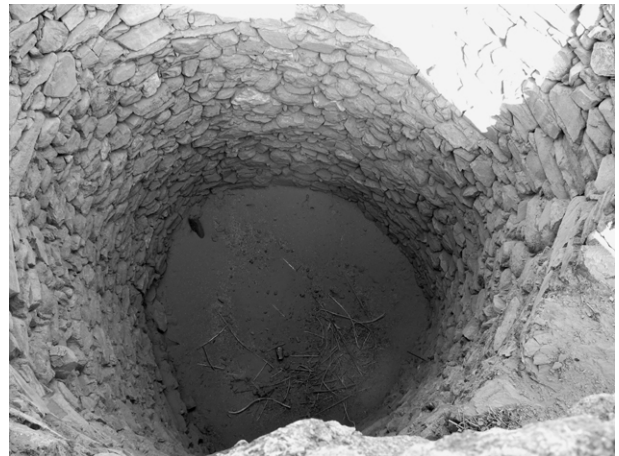
Fig. 12: Site 450 - Well

In the Wadi itself at least 4 wells were shown to us in direct vicinity of Umm Ruweim. Two of them are in function, two are dry. One of the dry ones is built by stones, the upper part restored with concrete. The lower part, approximately 6 m deep to the sand, on the ground of the well, is well-built with slabs of stones. It is possible that this well is older, but only excavation can proof this (Fig. 12).

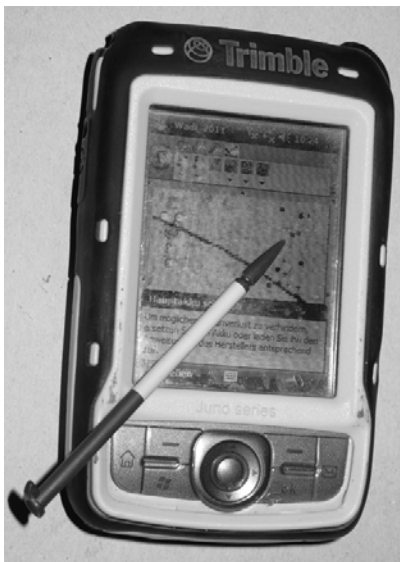
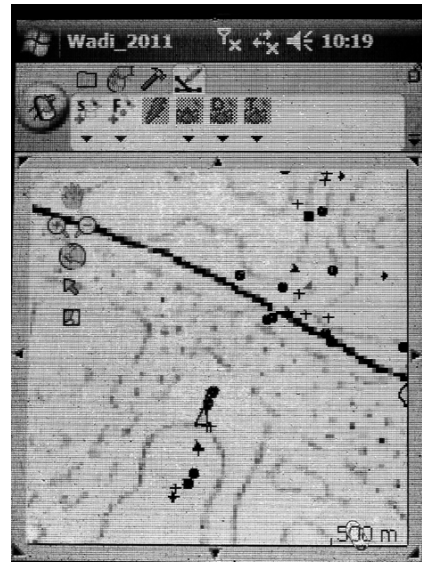
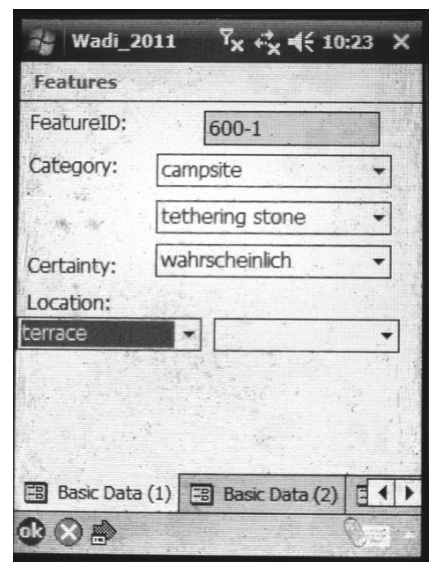
Fig. 13: Trimble with ArcPad 10: Sheet with map, sheet with entry form

Customizing ArcPad 10: The software should support the organisation of the data acquisition to proceed from handwritten, intuitive data acquisition in the field to systematic, GPS-and PDA-based data acquisition (Fig. 13). The database of the campaigns of 2010 and 2011 was used as basis to exemplify suggestions for systematisation. The data acquisition is individualized (for specific features specific data are required). Photographs and sketches are embedded in the database and georeferenced completely. There is an airphoto management program running at the PDA, too. In the future, we can not only search for data in the database in the field, but also start query and compare entries, photographs and sketches right in the field.

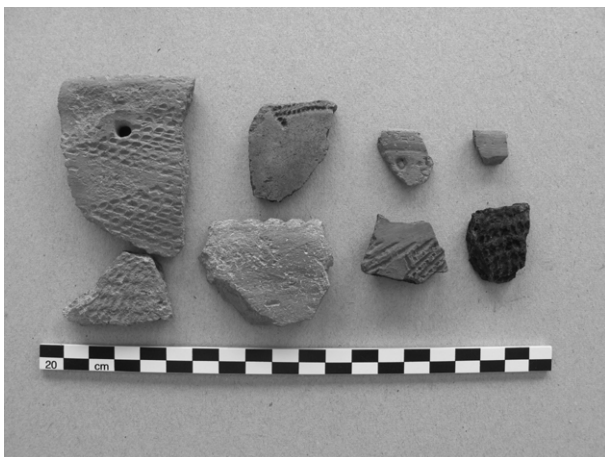
Fig. 14: Pottery from Sondage A

All in all, 1778 sherds are documented so far, 376 of them also drawn. The finds are completely photographed and included in a database. The pottery covers the periods from neolithic up to the medieval and possibly islamic time. This year again new fabrics were identified, most of them from pottery found within the sondages in Umm Ruweim (Fig. 14, 15). Especially this pottery seems to be of higher quality in comparison to the pottery from the survey. Some of the fabrics seem to be non-local.

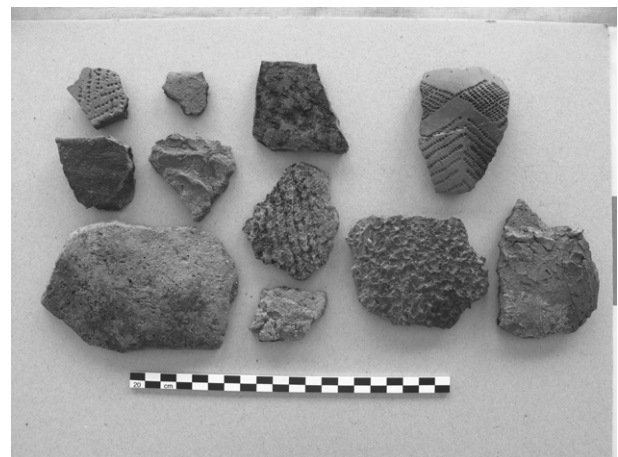
Fig. 15: Pottery from sondage C
