# Report of the Project "Wadi Abu Dom Investigations III – El Rum Oasis" Thirteenth Season, 20.01.-15.03.2020

**Angelika Lohwasser/Tim Karberg**  
University of Muenster, Germany

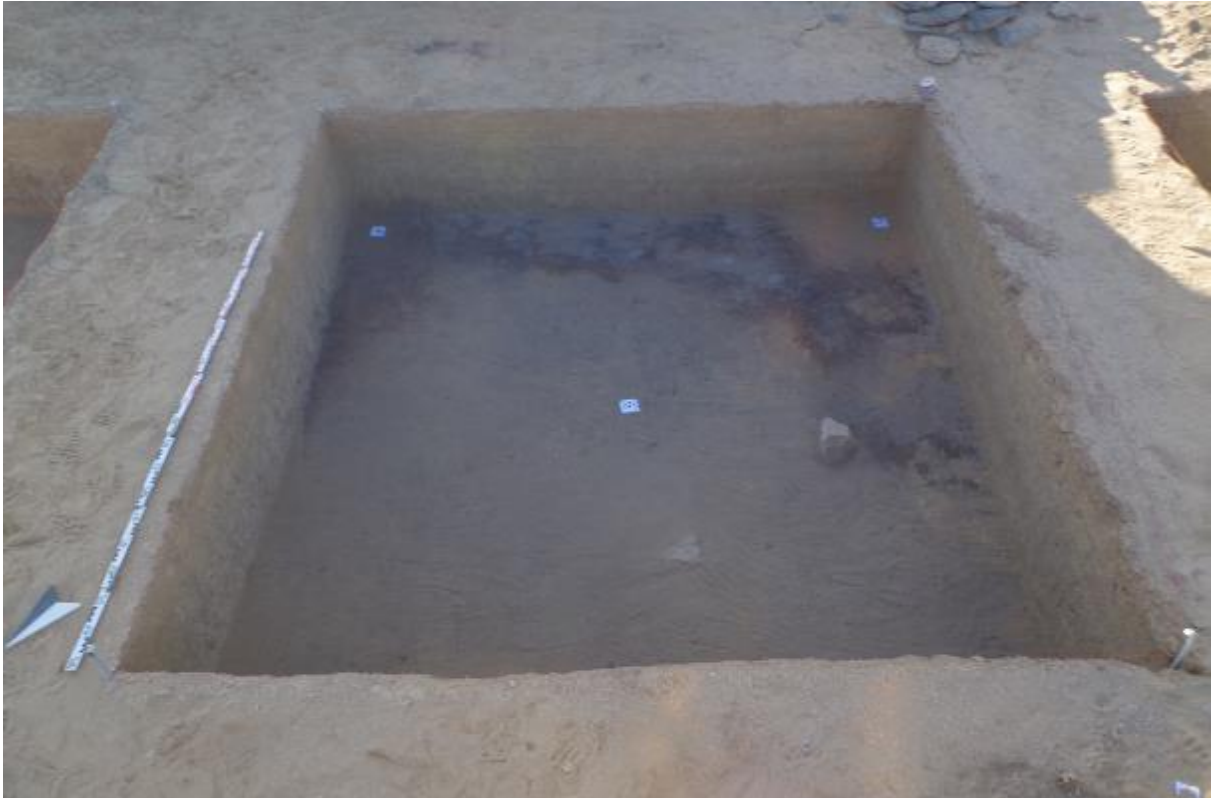
Figure 5: Trench 04 section east (with large lenticular ash concentration)

At a younger floor level, large scale lenticular ash concentrations (stratigraphically corresponding to the later plaster phase) indicate fires affecting this utilization phase (Figure 5); the structure and dimensions of these ash concentrations indicate destruction incidents rather than kitchen fires.

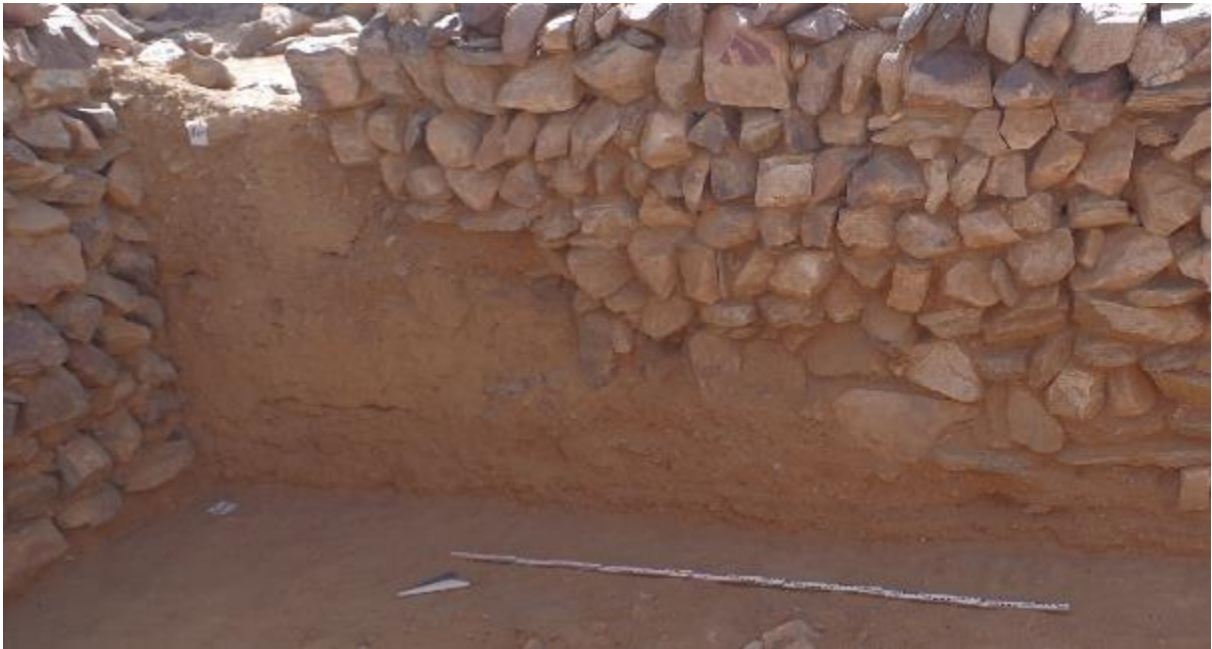
Figure 6: Pisé repairs at the eastern wall at trench 08

An interesting detail are some larger repairs close to the north-eastern corner of the room, carried out in pisé technique rather than mud brick (Figure 6).

This trench was set out at the eastern face of a wall already documented at trench 08 (cf. 3.1.2.1) in order to clarify the lower wall structure at the opposite face of the pisé repair. It turned out that at this face no traces of the repair are visible. This assumption shall be verified by excavating this trench until the geological soil in the planned forthcoming autumn campaign.

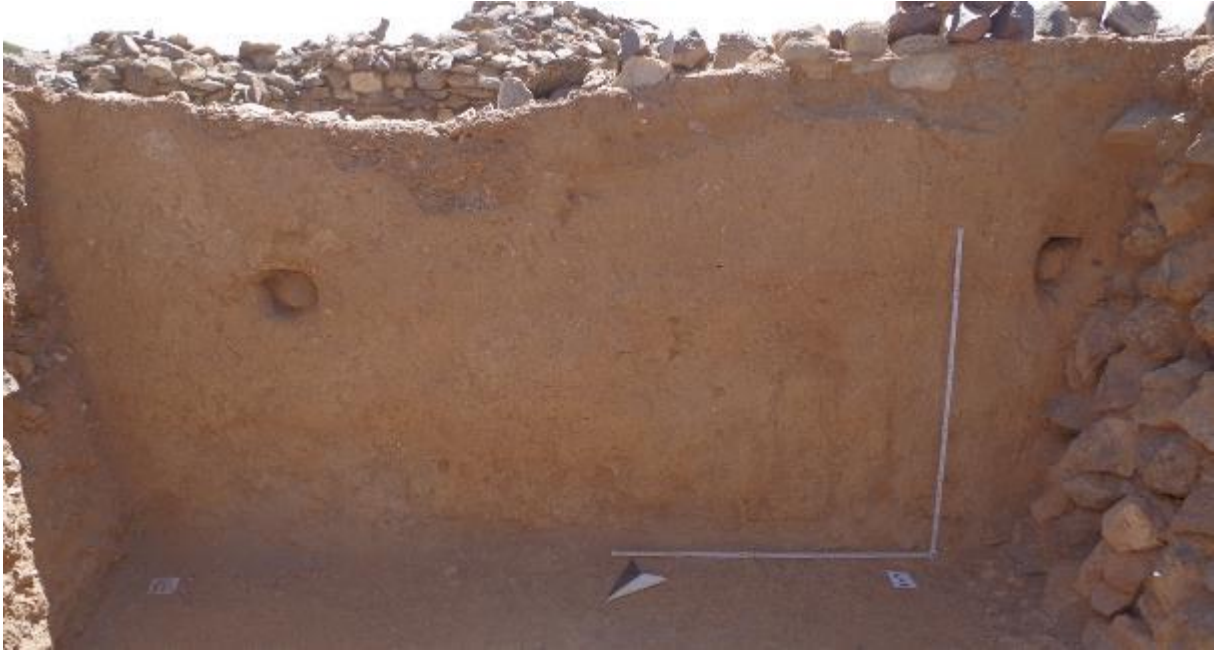
Figure 7: Plaster and small windows at the eastern wall at trench 09

Similar to trench 08, the room of trench 09 was intentionally terraced with bulk material, and the primary floor level shows no installations hinting to any initial utilization of the room. Interestingly, two of the interior walls are plastered with relatively soft mud plaster. At the eastern wall, two small windows were closed intentionally prior to the input of the terrace filling material (Figure 7). The plaster of the eastern and the northern wall prolong below the edges of the southern and the western wall, indicating that these walls are stratigraphically younger than the plastered ones. Nevertheless, the structure of the stratigraphy at the foots of these walls (as well as the internal logic of the architectural layout) lead to the assumption that this is caused by changes within the planning and construction process rather than two different building (and utilization) phases.

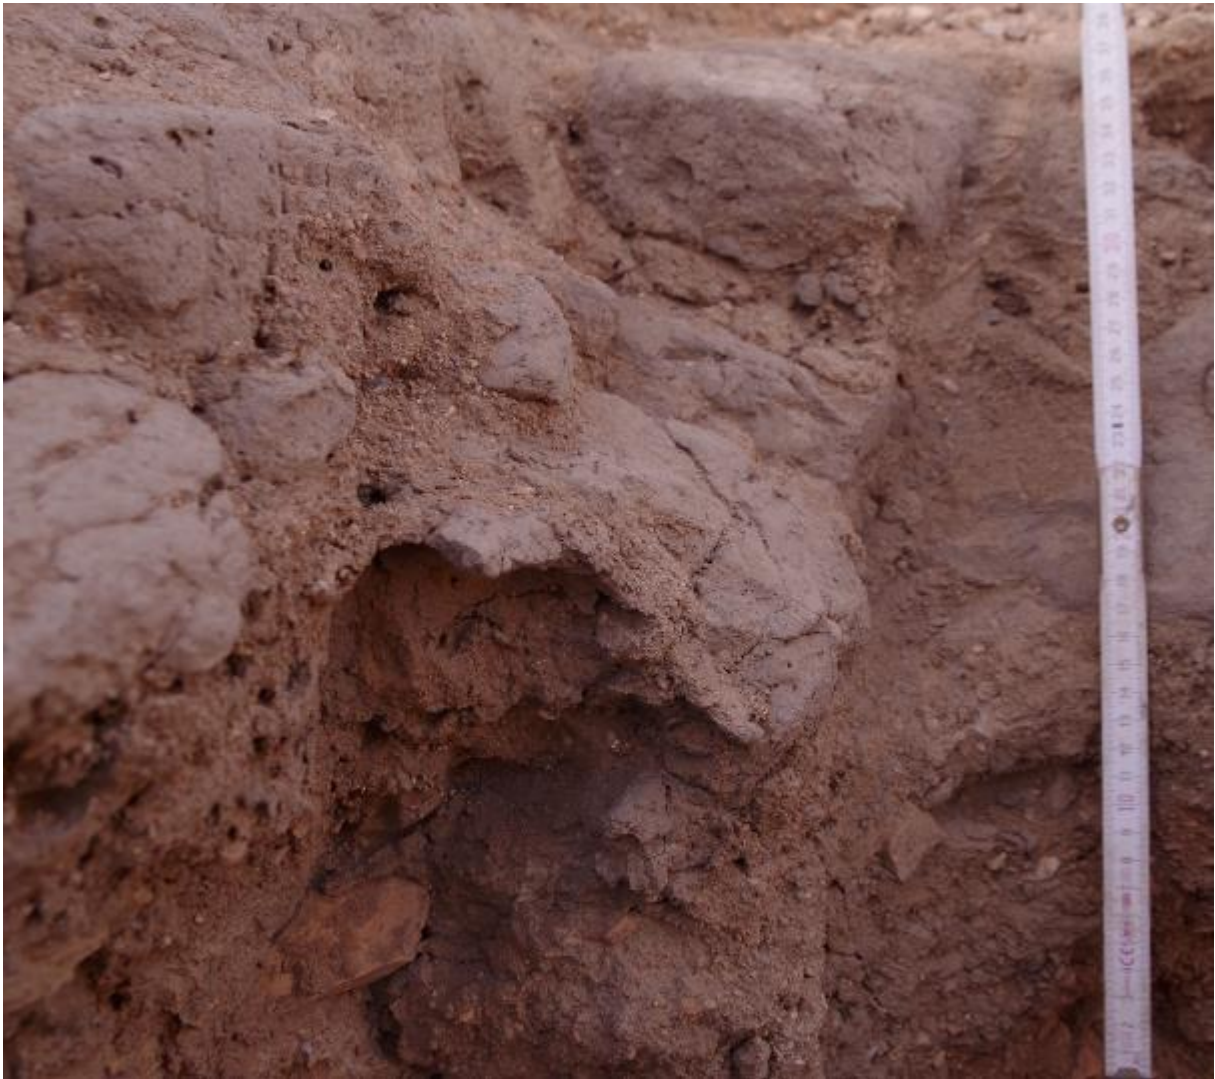
Figure 8: Inclined setting of mud bricks, probably remains of the foundation of a barrel vault

At the topmost level of the trench's stratigraphy, an inclined setting of mud bricks was documented, maybe remains of a vaulted roof (Figure 8). If this interpretation is correct, the barrel vault would have been erected on top of the intentional terracing, and not represent an earlier construction phase connected to any primary utilization of the original floor level.

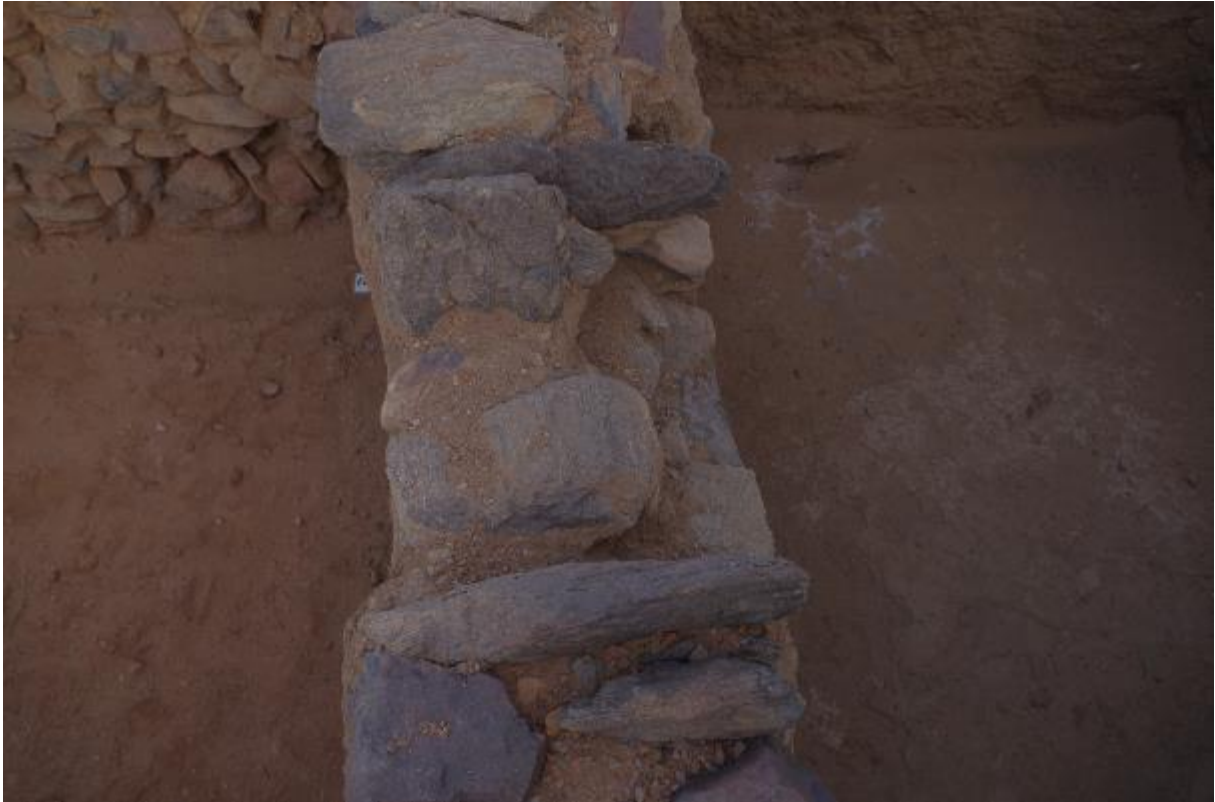
Figure 9: Opening in the upper part of the wall between trenches 09 and 15

An opening in the upper part of the wall between trenches 15 and 09 (Figure 9) might have granted access from the (lower) floor level at trench 15 to the (upper) terraced surface at trench 09.

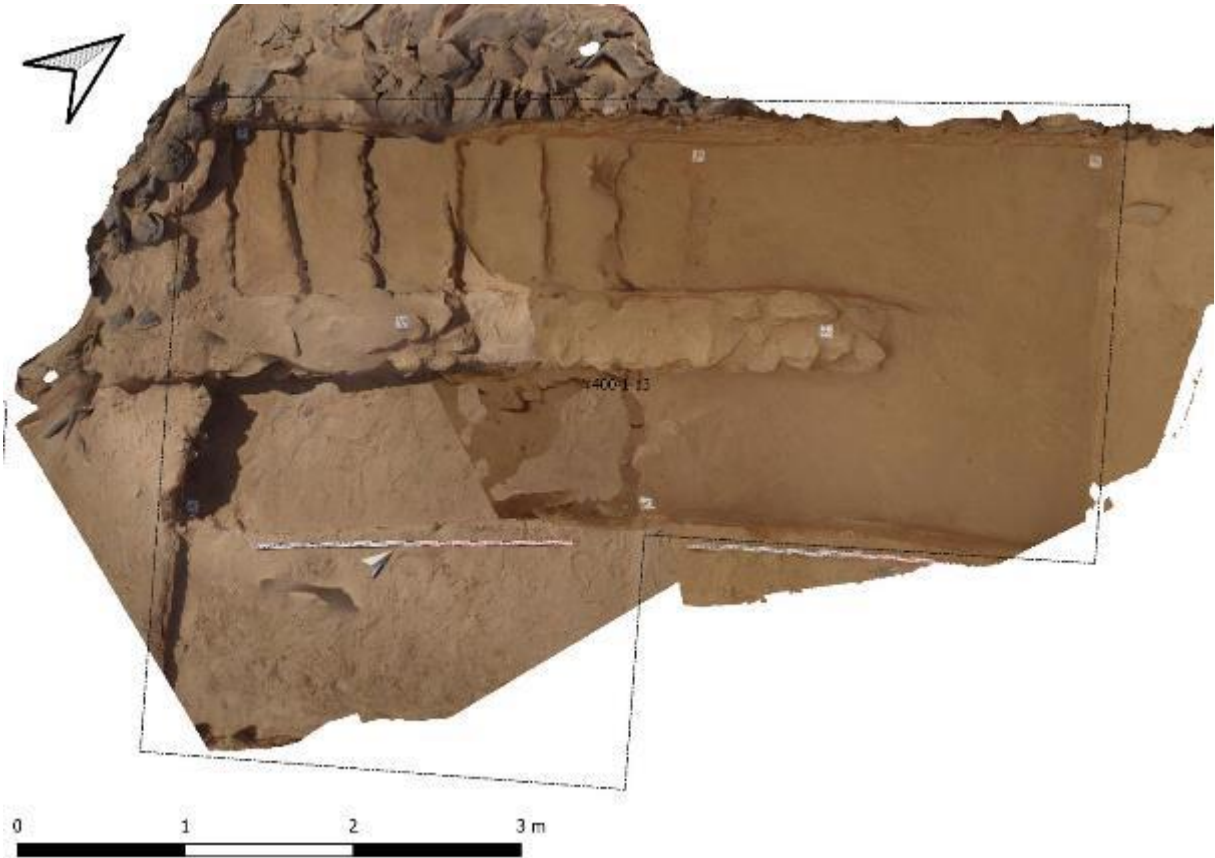
Figure 10: Staircase at trench 13 (assembled orthophoto segments)

This trench was intended to clarify the architectural and stratigraphic connection between the western wall of the middle casemate and the abovementioned platform construction, as well as the access to it. It turned out that access to the platform was granted via a large-scale staircase prolonging into the central courtyard at least 5,5 meters (Figure 10). The wall foot of this staircase was erected directly on top of the geological soil, and therefore stratigraphically contemporary to the casemate wall. The single stairs were made of stone slabs and reinforced by wooden beams still found in situ.
